VENDOR SERVICE BULLETIN
ATA 26-24
FIRE PROTECTION – FIRE EXTINGUISHER -
HIGH TEMPERATURE EXPOSURE - INSPECTION

PART MANUFACTURER	umlaut engineering GmbH
AFFECTED PART	Hand-held Fire Extinguisher HAFEX, model type: P3APP003010A P3APP003010B P3APP003010C

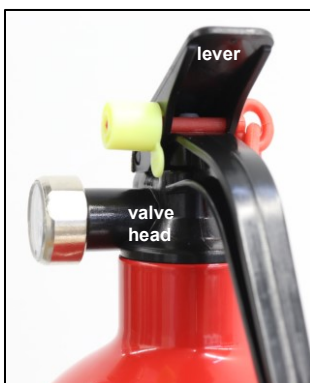
Figure 2: upright position

1. Remove the fire extinguisher from its bracket. **Refer to CMM 26-24-02 page 12001.**
2. Put extinguisher in upright position onto a flat and even surface with safety pin in place (Figure 2).
3. Push the lever up carefully with low force and using only one finger (Figure 3).
4. Release the lever.
